Using Dynamometer Data

Example 2: Worn Plunger – Worn Traveling Valve

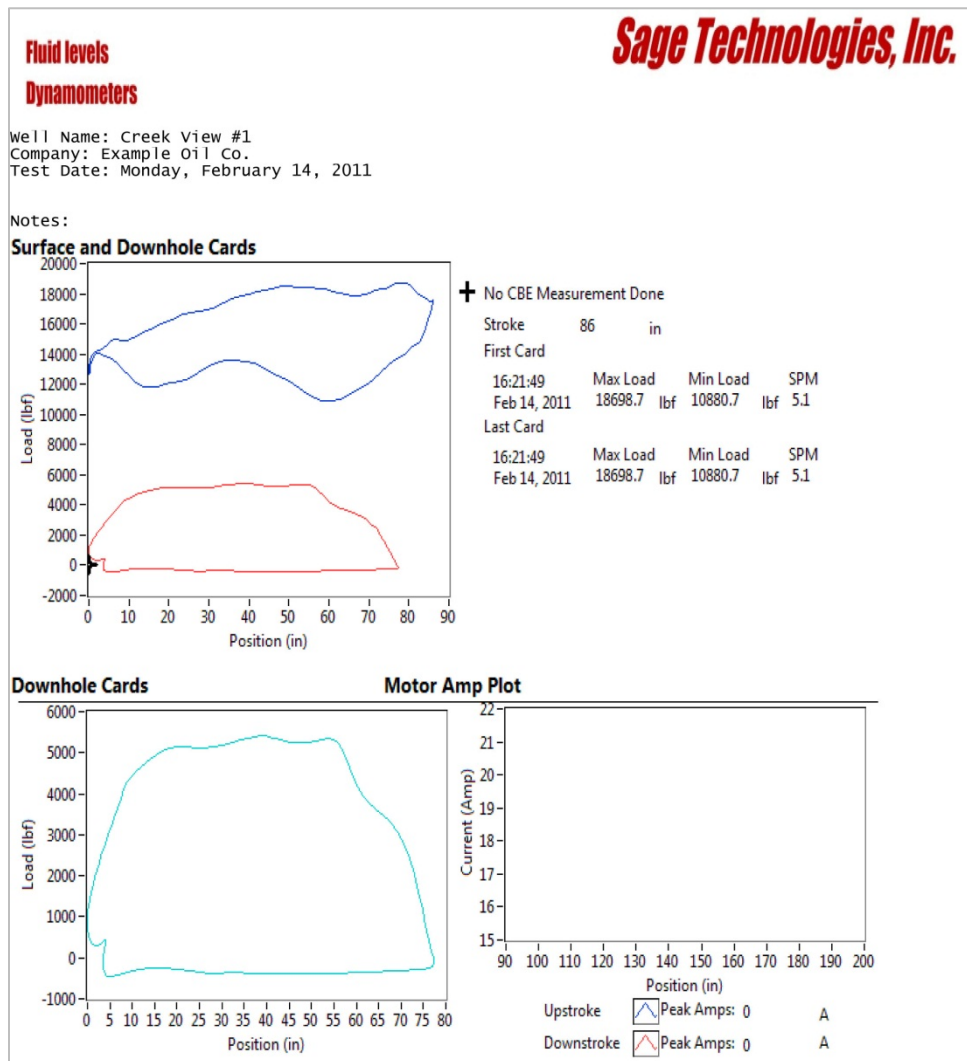
Well is running on Ajax gas engine. Fluid Level is shot and fluid found at 6231 ft.
The high fluid level with such small current production is indicative of pump problems.
A dynamometer is run on the well.

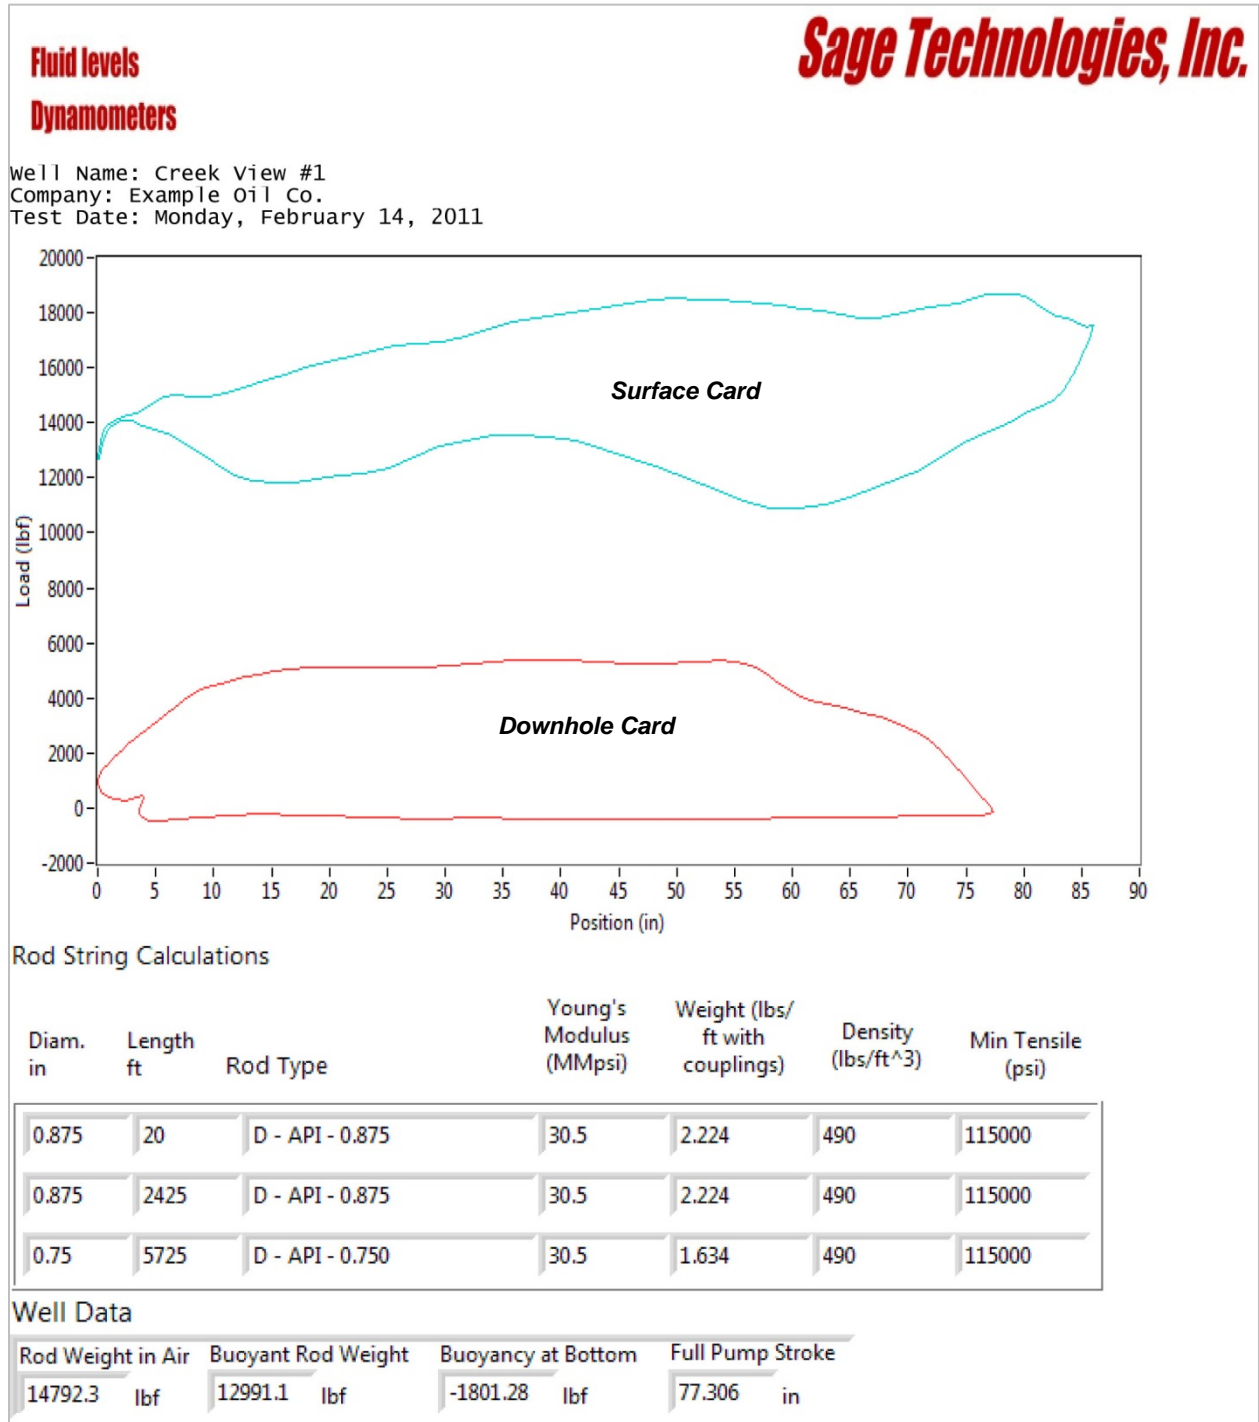
The downhole card shape as shown below indicates a worn plunger or worn traveling valve.

Even though new pump has been run during completion, it is evident that there has been damage. Pump is pulled and damage confirmed. Damage had been caused by inadequate clean-up after acid job.

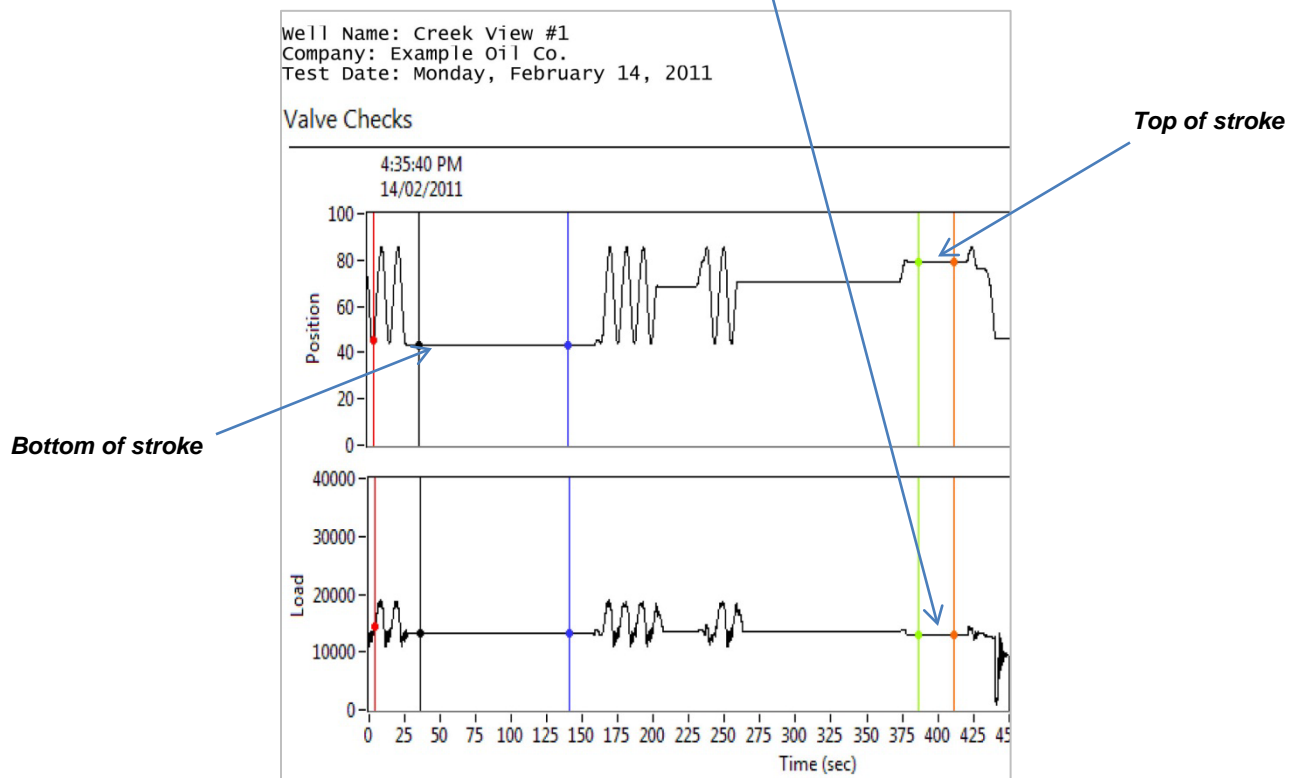
After identifying the appropriate downhole card shape, a valve check test is run to confirm valve problems. Valve check shows that no load is held on the **upstroke**, signaling a damaged traveling valve.
