Using Dynamometer Data

Example 2: Worn Plunger – Worn Traveling Valve

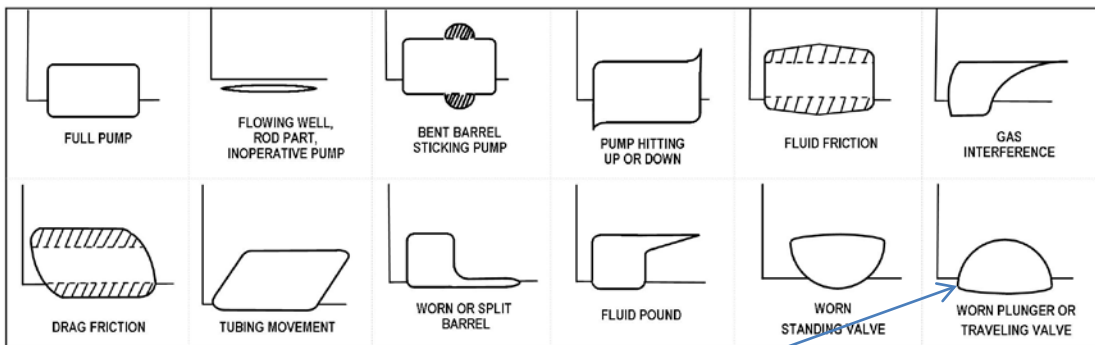
Typical Downhole Dynamometer Card Shapes

The downhole card shape as shown below indicates a worn plunger or worn traveling valve.

After identifying the appropriate downhole card shape, a valve check test is run to confirm valve problems. Valve check shows that no load is held on the **upstroke**, signaling a damaged traveling valve.

Even though new pump has been run during completion, it is evident that there has been damage. Pump is pulled and damage confirmed. Damage had been caused by inadequate clean-up after acid job.
